SSC Case Study V

Container Ship

Recurring Failure of Side Longitudinal Passing through a Web Frame

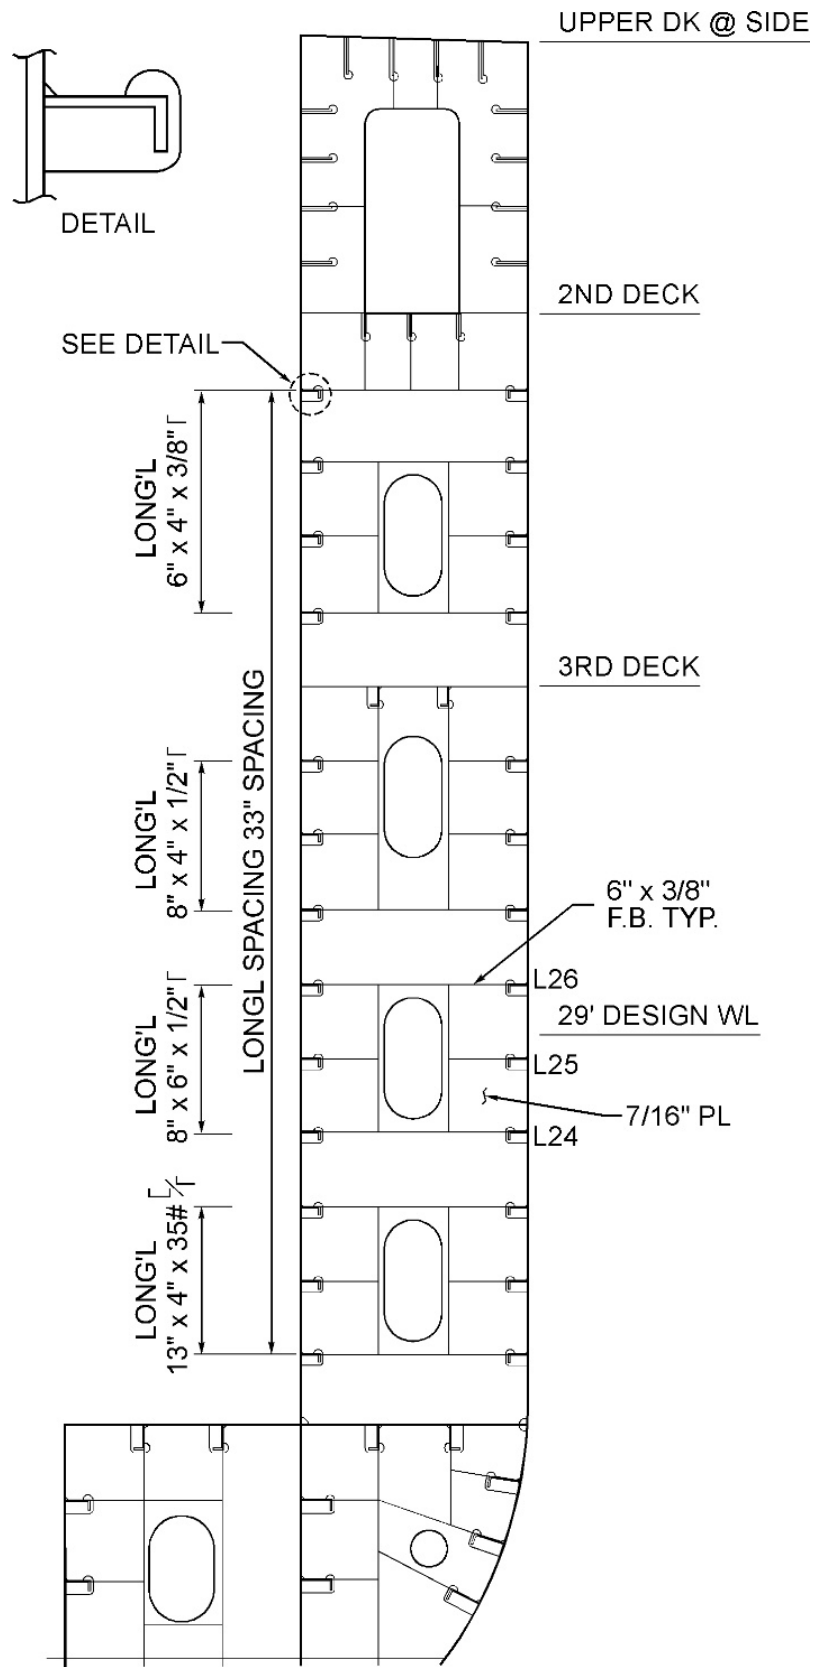
Figure 1. Wing Tank Longitudinal Stiffeners

In the longitudinally framed portion of the hull (from hold 1 through hold 6) the web frame spacing is 11.00'. The longitudinals are spaced 33" apart in the wing tanks and consist of angles and channels cut to angles. Beginning below the box girder the shell and bulkhead longitudinals increase in size from 6" x 4" x 3/8" to 8" x 6" x 1/2" angles before switching to 13" x 4" x 35# cut channel, as shown in Figure 1.

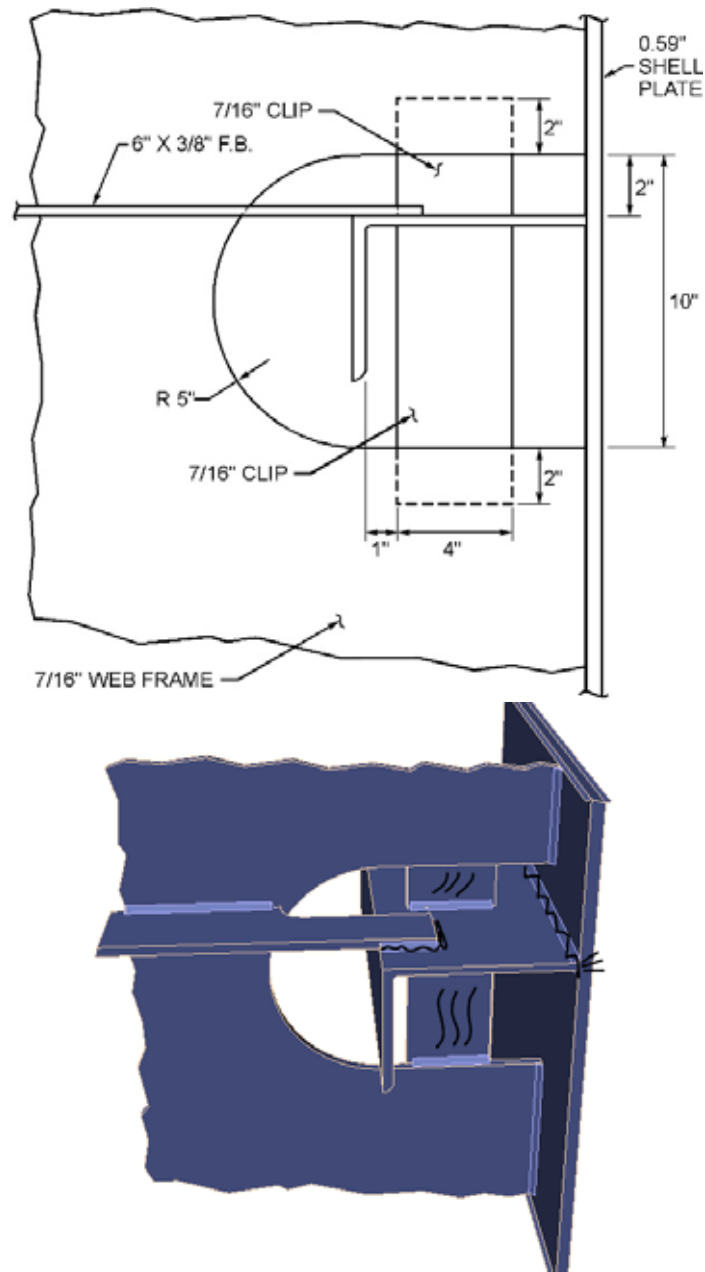
Figure 2. Original Cutout Detail for L24 to L26, 8" x 6" x 1/2" Longitudinals

For convenience during construction the web frame cutouts for longitudinals were made clear all around as shown in Figure 2 instead of the more normal type of cutout detail indicated in Figure 1.

The cause of these failures is poor detail design, incorporating the large open cutout for the longitudinals and the highly eccentric 8" x 6" angle longitudinals, in an area of the ship subject to repetitive impact loading from waves. Figure 2 illustrates how the longitudinal is not adequately supported.

Most of these failures begin when the web frame flat bar stiffener on one of the shell longitudinals, L24 through L26, fractured at the longitudinal or the lap weld of the stiffener to the longitudinal. With the stiffener no longer providing support all of the loading on this "wind and weather" strake longitudinal is transferred to the web frame through the poorly proportioned clips on the 8" x 6" angle. The clips buckle under the load. The buckled clips combined with the 10" of unsupported shell in way of the web frame cutout allow the longitudinal to flex in bending and torsion at what should be a rigid support at the web frame. This lack of support combined with the large web frame spacing and the load induced twist in the eccentric 8" x 6" angle raises the stress level in the longitudinal causing it to fracture about 12" from the web frame at a drain hole in the angle. After the longitudinal fractures, a fracture forms in the weld of the longitudinal to the shell plating that travels a short distance back toward the web frame. As this fracture lengthens toward the web frame the stress in the shell plating increases and, when combined with the elevated shell plating stress in way of the large longitudinal cutout, causes the shell to fracture. The shell fracture is in the form of a small half moon centered over the longitudinal's web near the edge of the cutout. Fuel oil then leaks from this half moon shell fracture.

It is believed that the initial web frame flat bar stiffener and weld fractures occur because the angle type longitudinals twist as they bend under the load of wave impacts on the shell. This twist is exaggerated in an angle with eccentric proportions of 8" x 6". The twist puts a torsion load on the connection of the longitudinal to the web frame. For this detail the connection consists of only the flat bar stiffener and the two poorly proportioned clips. Such a connection does not resist torsion loads well leading to fatigue failure of the weakest link, the 6" x 3/8" flat bar stiffener or its weld.
