Project Report

FIELD INVESTIGATION OF VALVED SOFFIT VENTS IN POUCH COVE NL:
IN SITU HOUSEHOLD VSV PERFORMANCE
APRIL-JULY 2006

PR. CM2006_01
Industrial Outreach Group
November 30, 2006
St. John's, Nf. Can

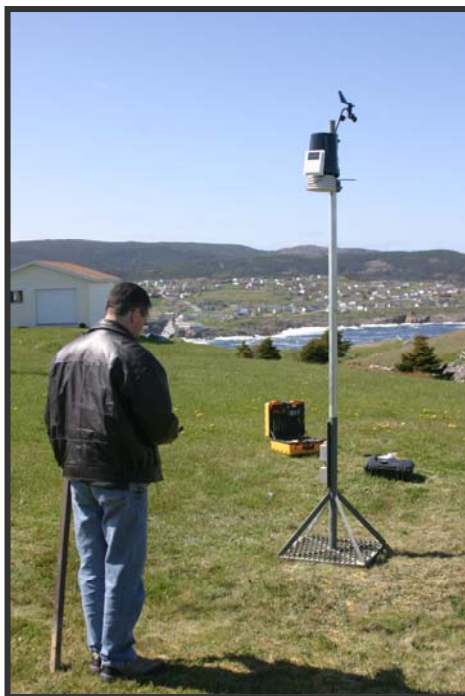
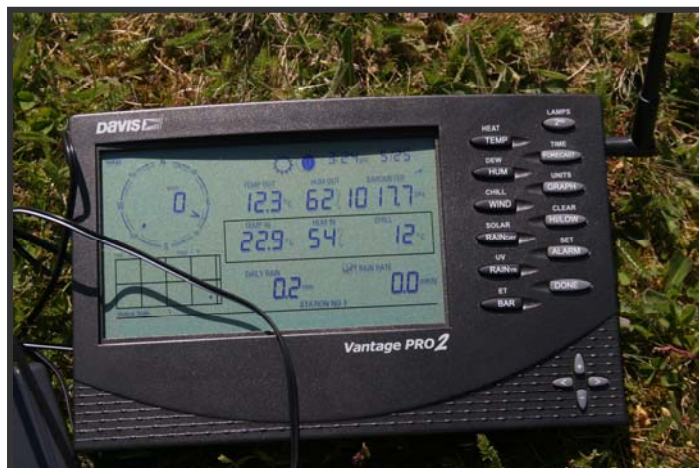
Meteorological Station Components
Left = Weather Instruments
Above = Data Display and Logging Unit

The sensors and instruments of the met station measured wind speed, direction, duration, temperature, humidity, barometric pressure, solar radiation and precipitation. The Davis logging unit communicated with the instruments via wireless radio transmission and displays instantaneous conditions while recording peaks and averages on a 10 minute interval basis.

The met station utilized for the study was a DAVIS Vantage Pro 2 System – a high-end private-use kit often used for low-end commercial applications. It was an inexpensive in-stock item that had a high degree of flexibility and reliability in non-extreme weather environments like that expected at the Pouch Cove test site during summer months. The unit shown below is essentially comprised of two parts: an indoor display and recording unit, and an array of instruments and sensors for placement outdoors.

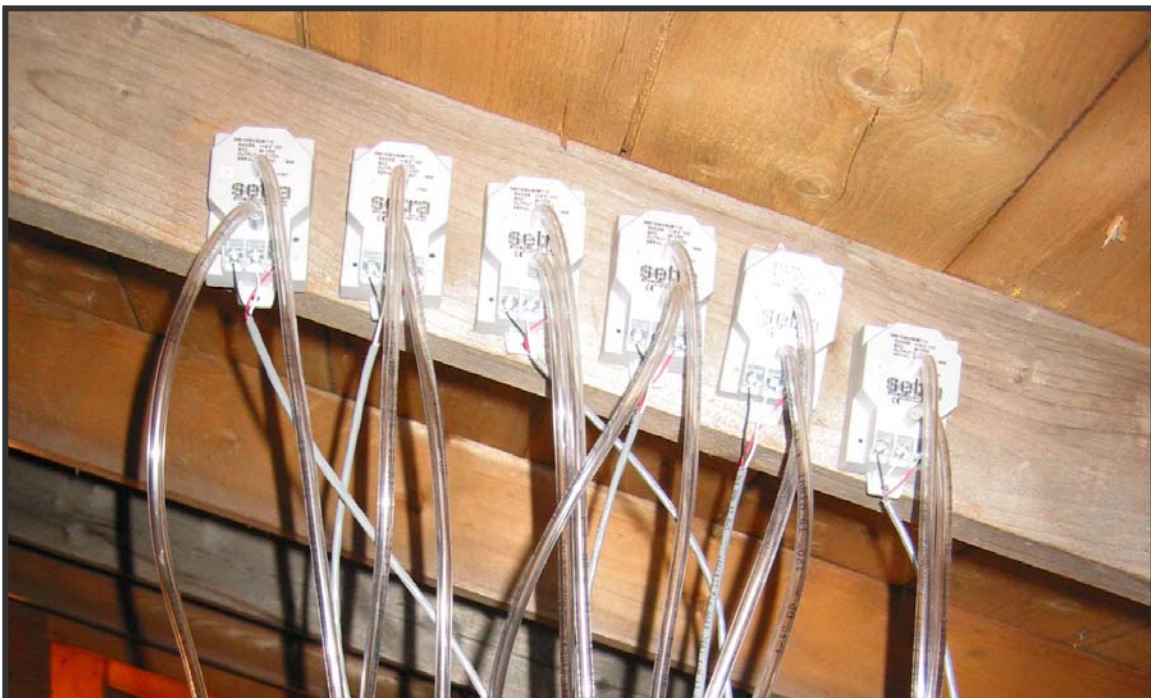
The six transducer units have electronic terminals for power supply and output, plus a high and low pressure pneumatic connector. From each connector 3/16" vinyl tubing is run to the desired measurement location (high) and to pressure datum (low), respectively. The manufacturer stated that tubes extending less than 50 feet would in no way adversely affect readings thus allowing the installation of all transducers at a convenient central location with tubes radiating outwards towards the desired pressure points. The photo below shows the bank of transducers as-installed in the attic space:

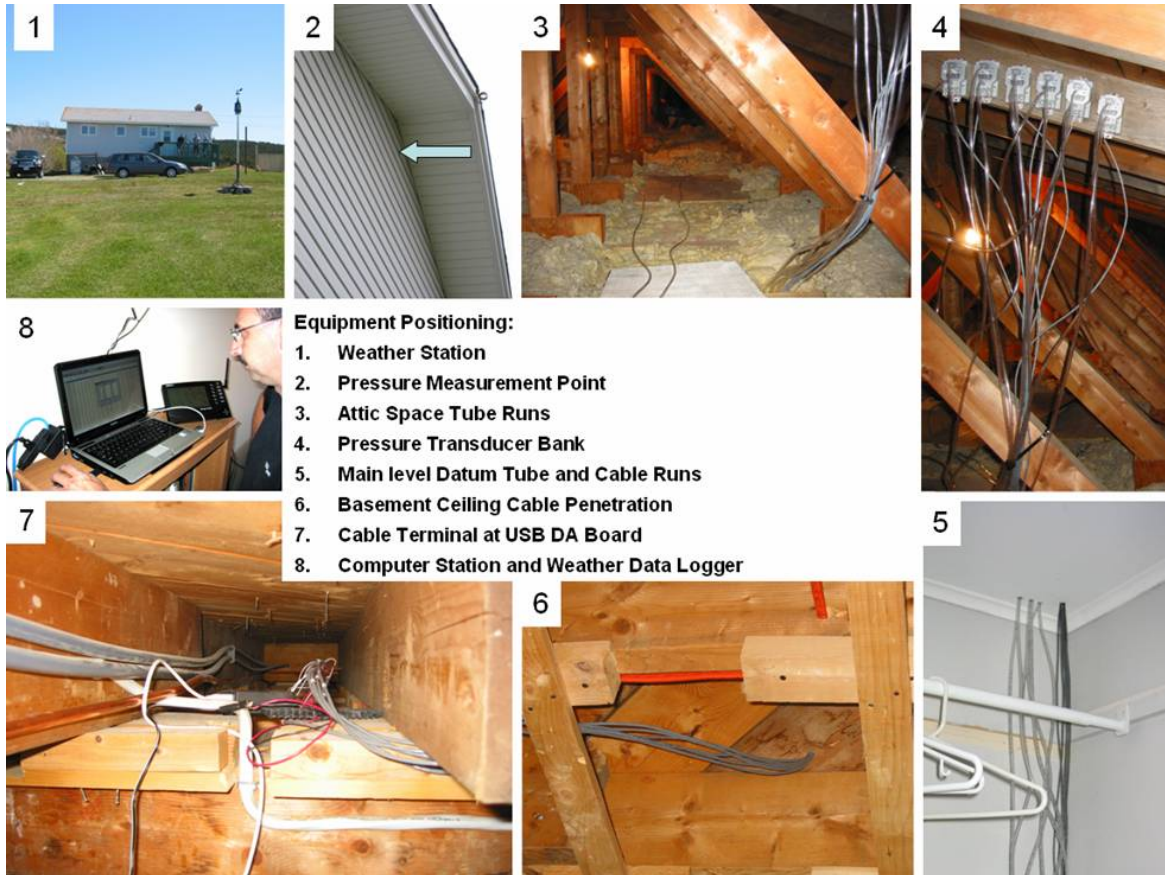
The low pressure datum where all six tubes terminated inside the house was in an open bedroom/closet space isolated from the attic and open to the main and lower levels of the bungalow. The transducers were electronically connected to the external USB DA board (Data Foundry, 16 ch. unit) via cables running through the main level ceiling and floor into the basement of the test house where the terminal was stored.

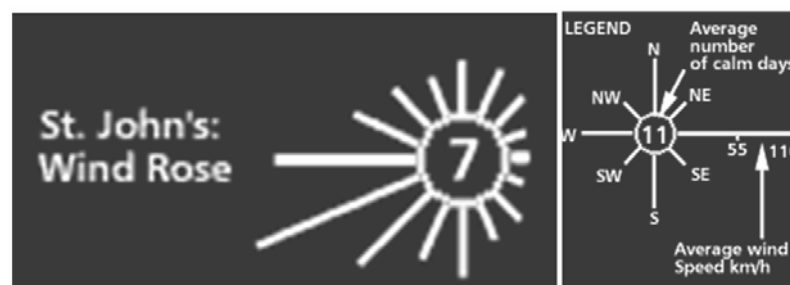
A detailed discussion of the wind environment at the nearby International Airport is Provided in Appendix E. During the six week window of operation wind strengths were equal to, or above, seasonal in persistence and magnitude, direction was as expected.

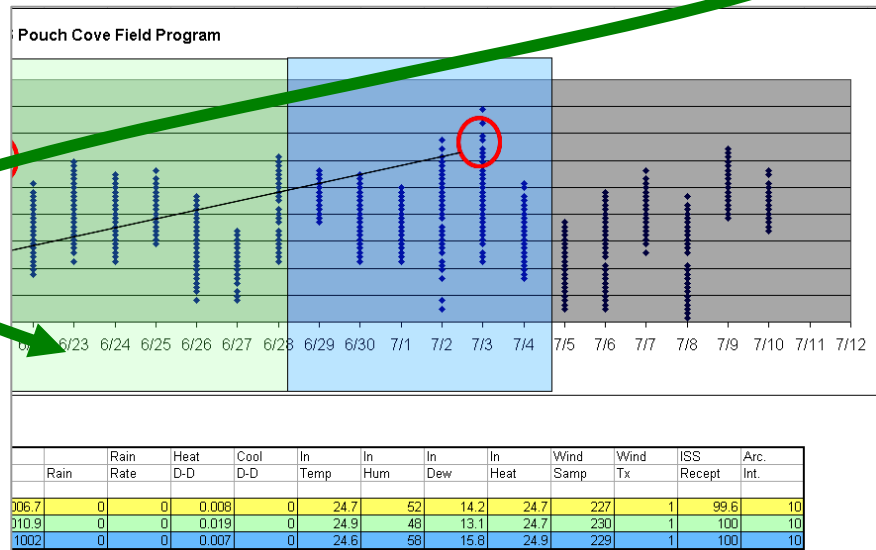
After scrutinizing the data sets it was found that three independent but similar wind events occurred for each house venting condition. These occurred on June 5th, June 21st and July 3rd - in all three instances sustained winds of 37 kph and peak winds of 61 kph from the SW quadrant were recorded over a ten minute interval.

*Plot and Table split
for legibility in
report*

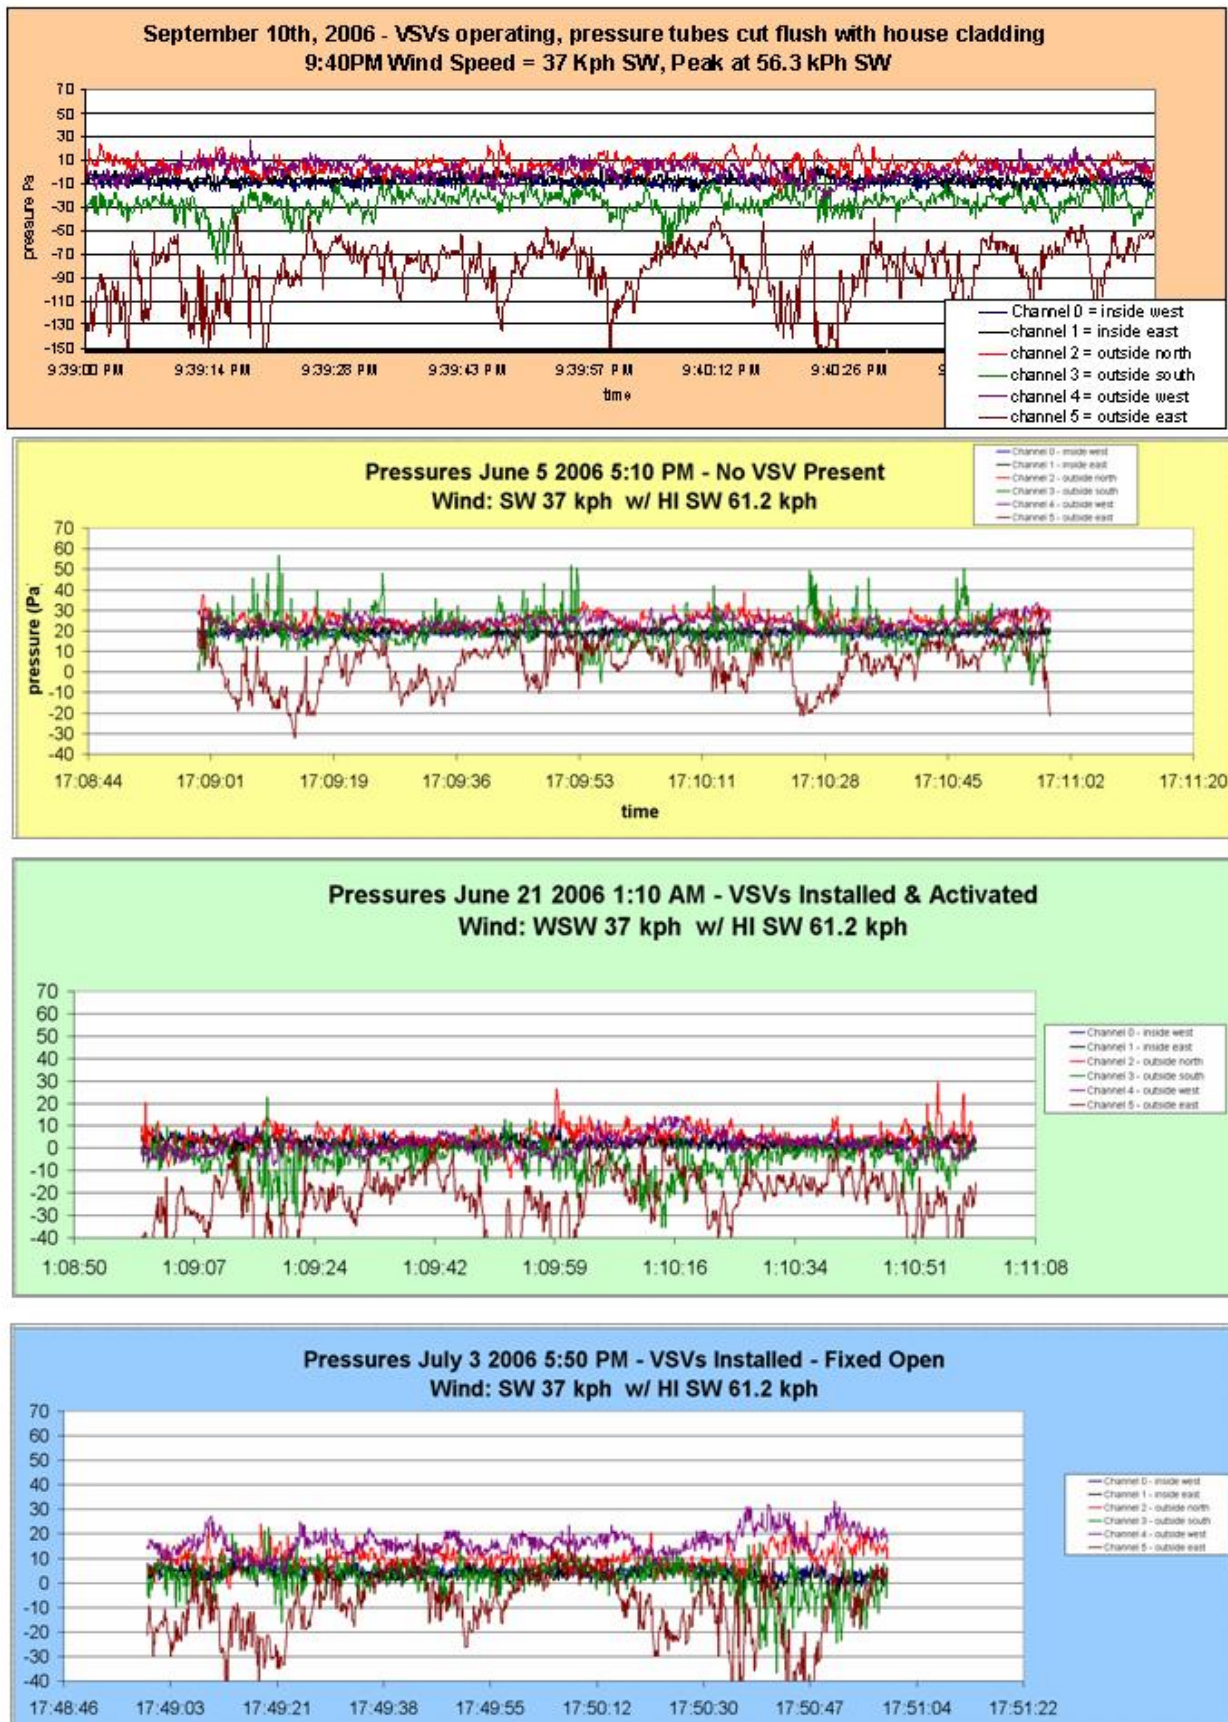
To analyze the effect of tube terminations a wind event with the same characteristics as the three previously analyzed events - was identified. An identical analysis procedure was undertaken and the results plotted (below with others). The similarity of this plot with the others indicates that the degree of rapid pressure flux, the relative variation between sensors and the significant negative displacement of the lee-side pressure is a real and robust phenomenon and not an artifact of the experimental procedure or equipment. This result further suggests that the previous body of data for which these changes were not affected - is valid and representative. In summary, definitive and conclusive statements of VSV performance cannot be made given the first-order analysis presented.
