SSC Case Study V

Container Ship

Recurring Failure of Side Longitudinal Passing through a Web Frame

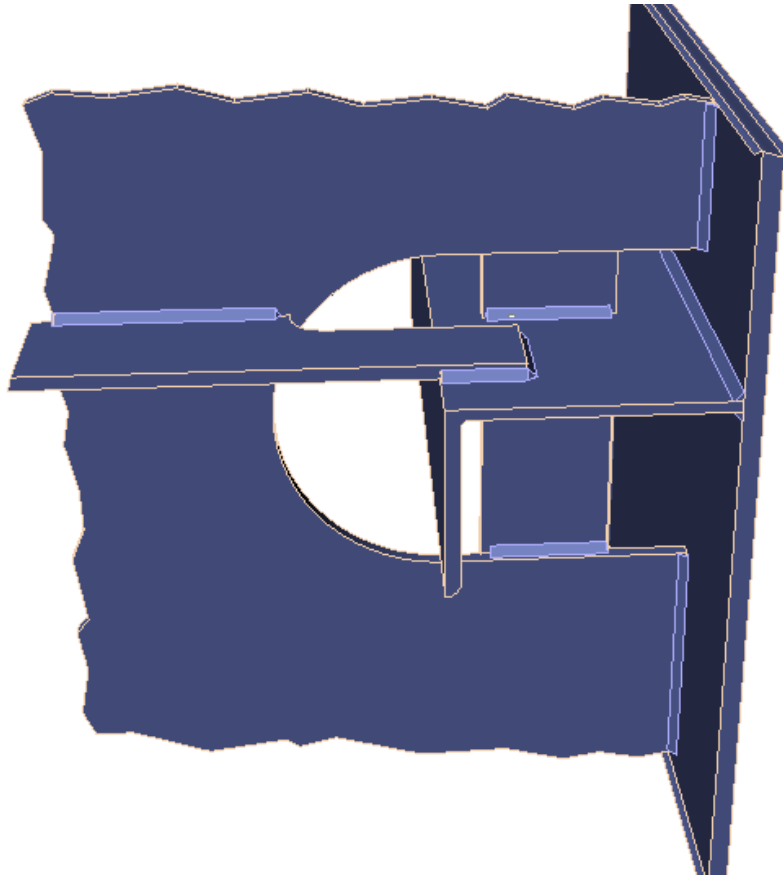
Progressive failure occurred beginning with the fracture of a web frame flat bar stiffener attachment to the longitudinal, buckling of clips between the web frame and longitudinal, fracture of the longitudinal, fracture of the longitudinal weld to the shell and finally fracture of the shell leading to a fuel oil leak. In some instances a similar fracture occurred in the longitudinal bulkhead.

The cause of these failures is poor detail design, incorporating the large open cutout for the longitudinals and the highly eccentric 8" x 6" angle longitudinals, in an area of the ship subject to repetitive impact loading from waves. Figure 2 illustrates how the longitudinal is not adequately supported.

Most of these failures begin when the web frame flat bar stiffener on one of the shell longitudinals, L24 through L26, fractured at the longitudinal or the lap weld of the stiffener to the longitudinal. With the stiffener no longer providing support all of the loading on this "wind and weather" strake longitudinal is transferred to the web frame through the poorly proportioned clips on the 8" x 6" angle. The clips buckle under the load. The buckled clips combined with the 10" of unsupported shell in way of the web frame cutout allow the longitudinal to flex in bending and torsion at what should be a rigid support at the web frame. This lack of support combined with the large web frame spacing and the load induced twist in the eccentric 8" x 6" angle raises the stress level in the longitudinal causing it to fracture about 12" from the web frame at a drain hole in the angle. After the longitudinal fractures, a fracture forms in the weld of the longitudinal to the shell plating that travels a short distance back toward the web frame. As this fracture lengthens toward the web frame the stress in the shell plating increases and, when combined with the elevated shell plating stress in way of the large longitudinal cutout, causes the shell to fracture. The shell fracture is in the form of a small half moon centered over the longitudinal's web near the edge of the cutout. Fuel oil then leaks from this half moon shell fracture.

It is believed that the initial web frame flat bar stiffener and weld fractures occur because the angle type longitudinals twist as they bend under the load of wave impacts on the shell. This twist is exaggerated in an angle with eccentric proportions of 8" x 6". The twist puts a torsion load on the connection of the longitudinal to the web frame. For this detail the connection consists of only the flat bar stiffener and the two poorly proportioned clips. Such a connection does not resist torsion loads well leading to fatigue failure of the weakest link, the 6" x 3/8" flat bar stiffener or its weld.
