Rubble Mound Breakwaters, Timber Crib Construction

Lecture Outline

Outline the theory behind and general structure of rubble mound breakwaters, along with the general processes and concepts associated with the construction of a timber crib wharf.

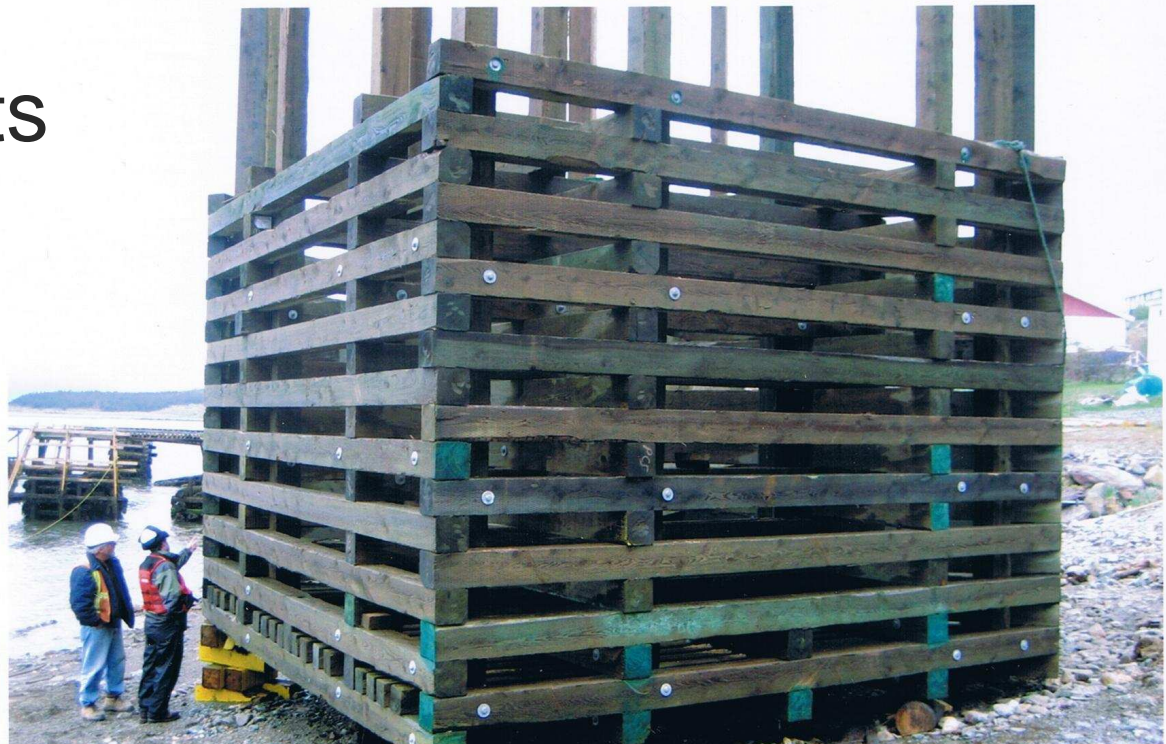
Crib – Before Launch

- Erected to +0.4 LNT
- Verticals
- Ballast Floor
- Treated Butts

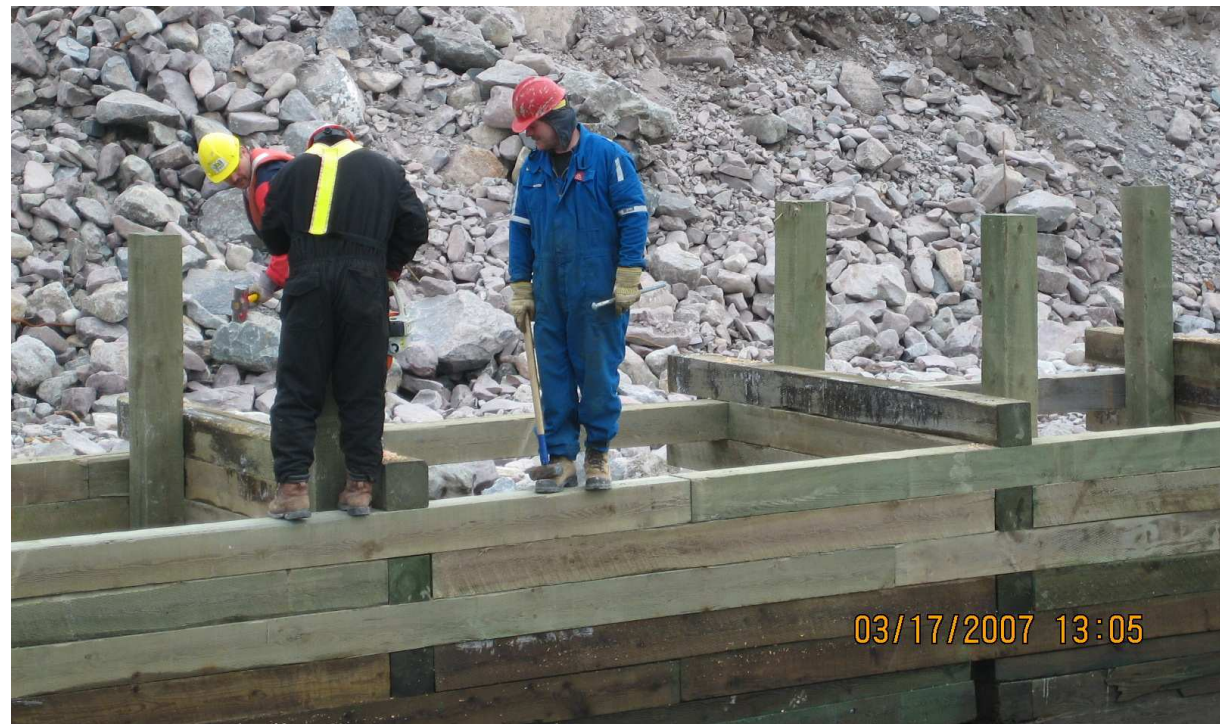
Marrying Cribs (Above 0.4 LNT)

- Butt ends to land in middle of crib bays
- Scatter location of joins evenly throughout

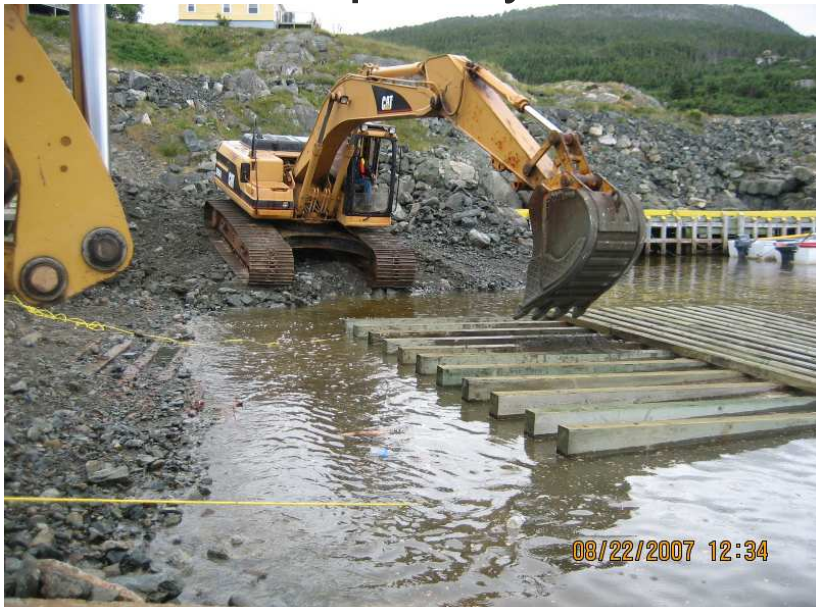
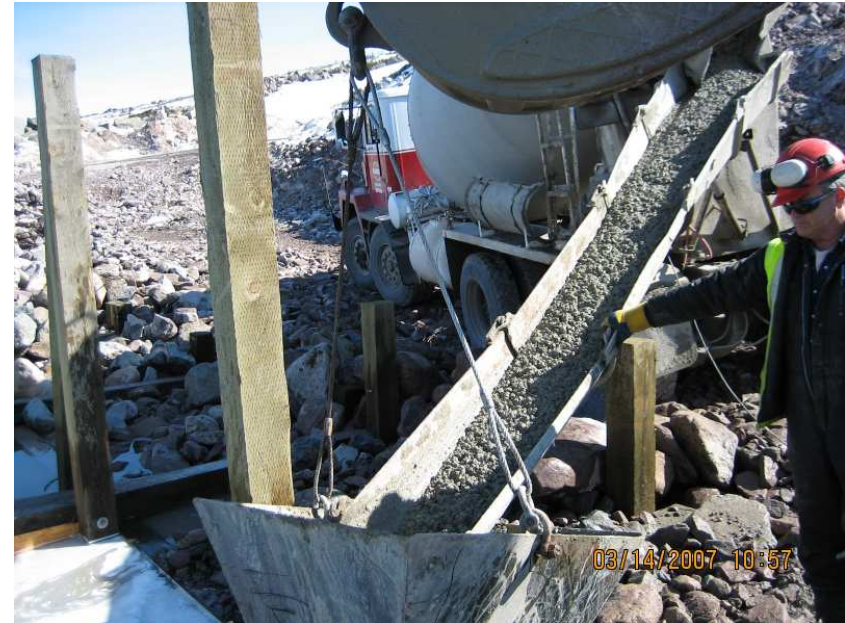
Crib Ballast

- Concrete
 - Tremie Pipe
- Rock (300mm)
 - Distribute evenly among bays until completely sunk

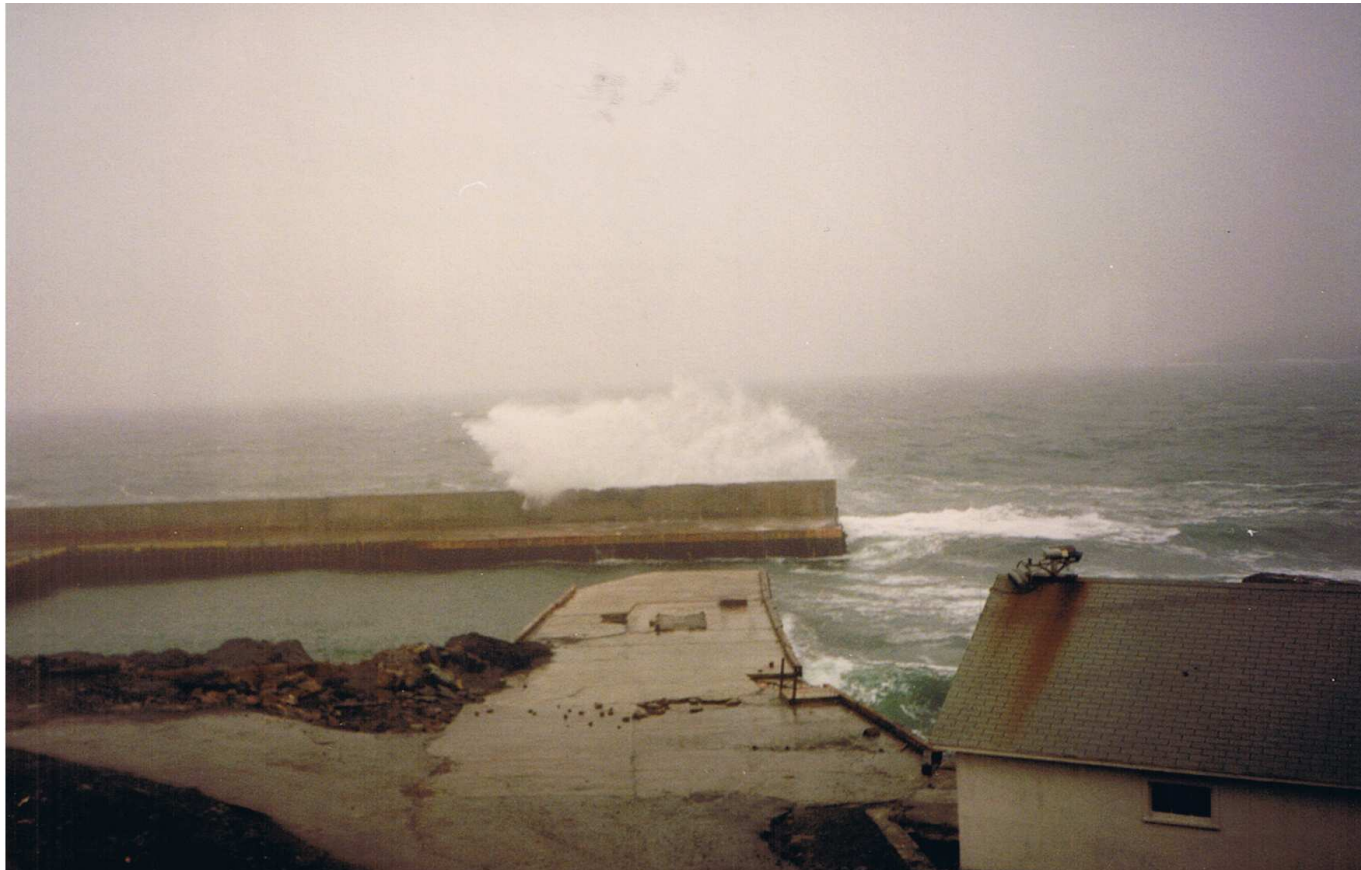
St. Shott's, 1991

- Site excavated to bedrock
- 12" pipe drilled, anchored to seafloor through crib structure
- Reinforcing steel tensioned
- Concrete filled cribs
- Concrete seawall installed

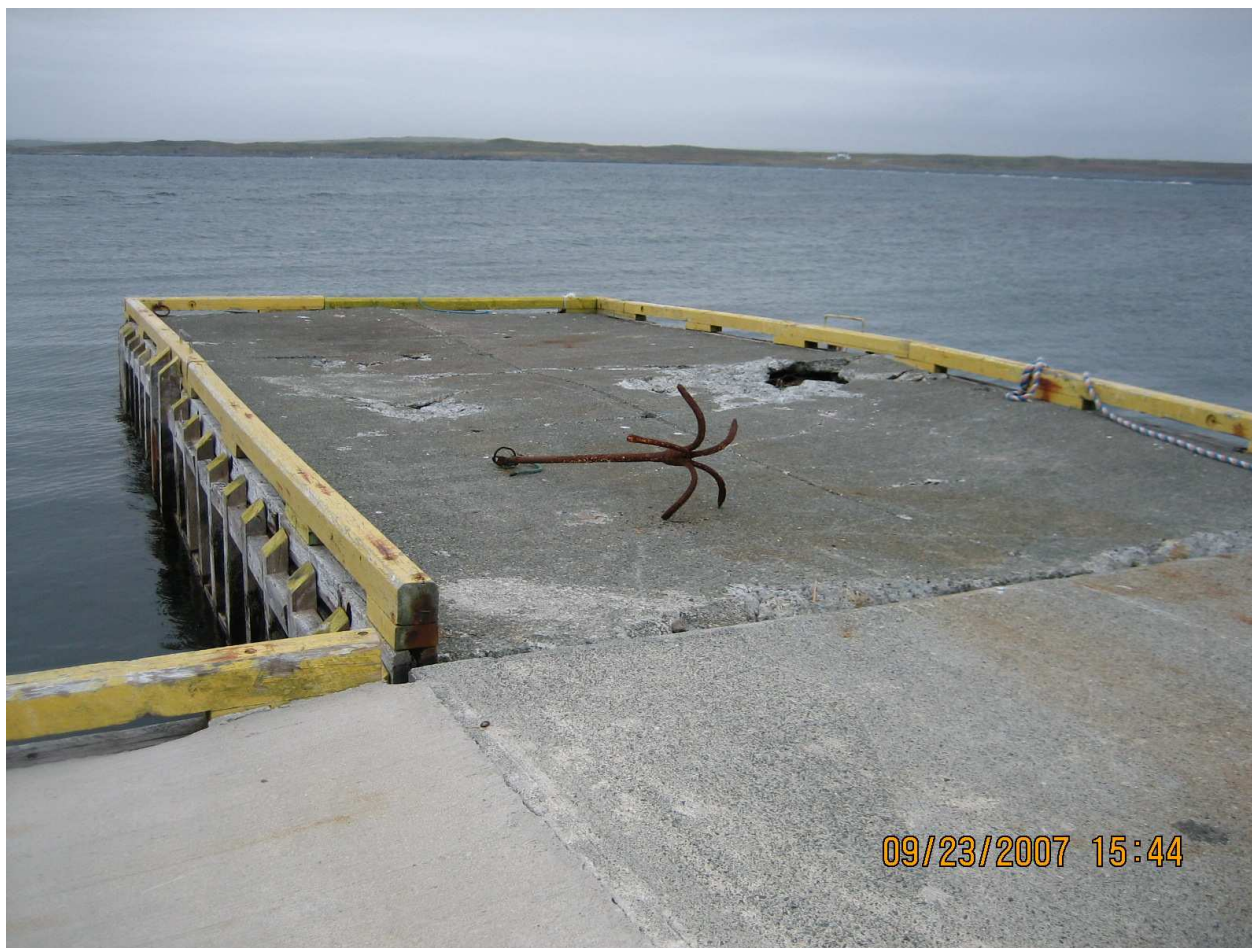
Portugal Cove South – Crib Seating Erosion

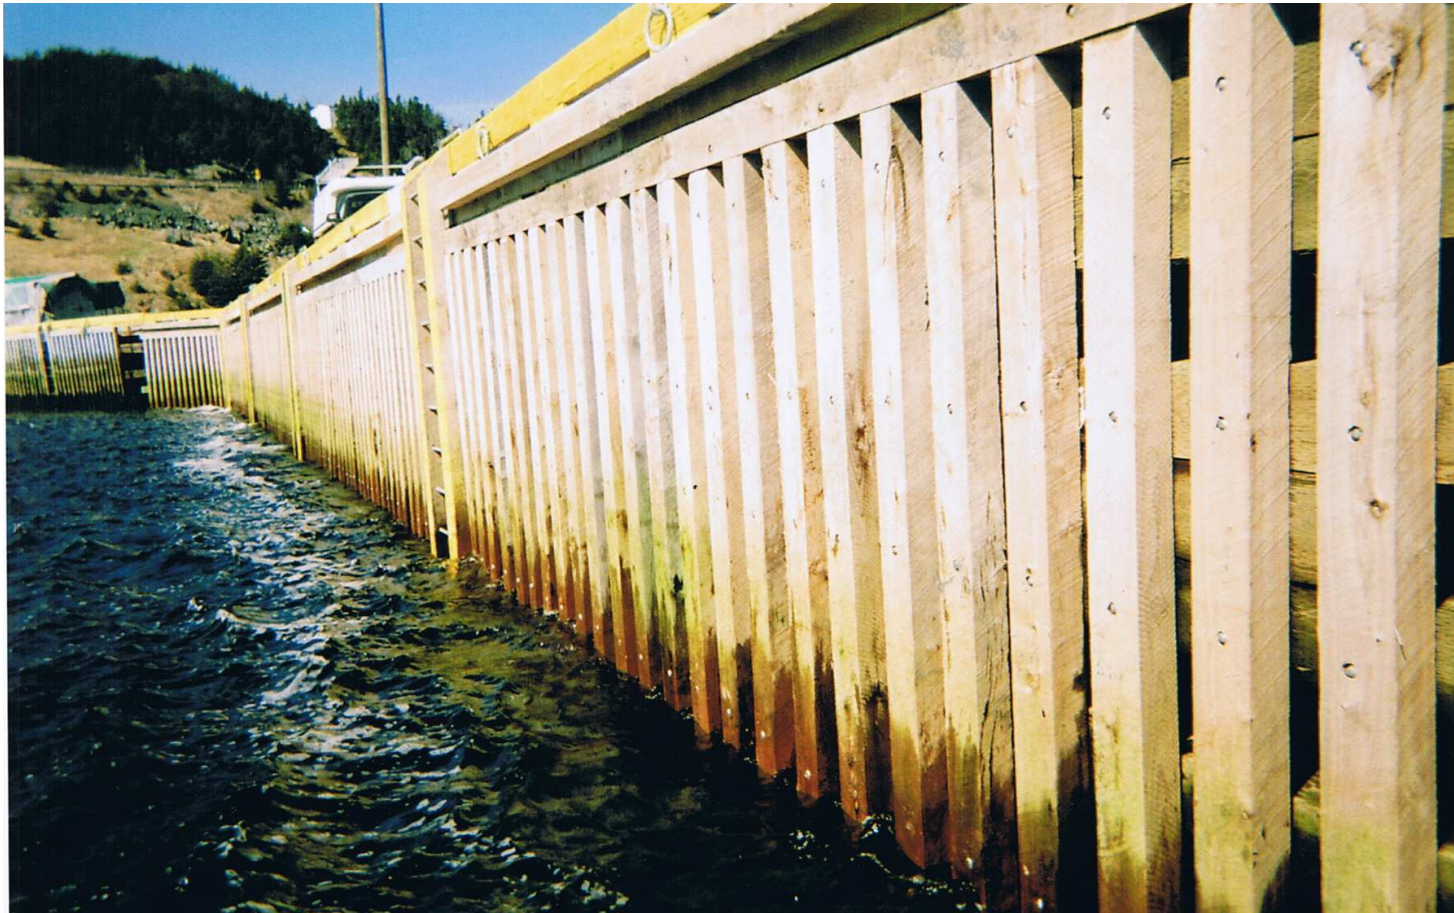
Solutions - Open Faced Fendering

- Dissipate wave energy
- Protect crib structure from collision
 - Ice
 - Boats
- Help retain ballast

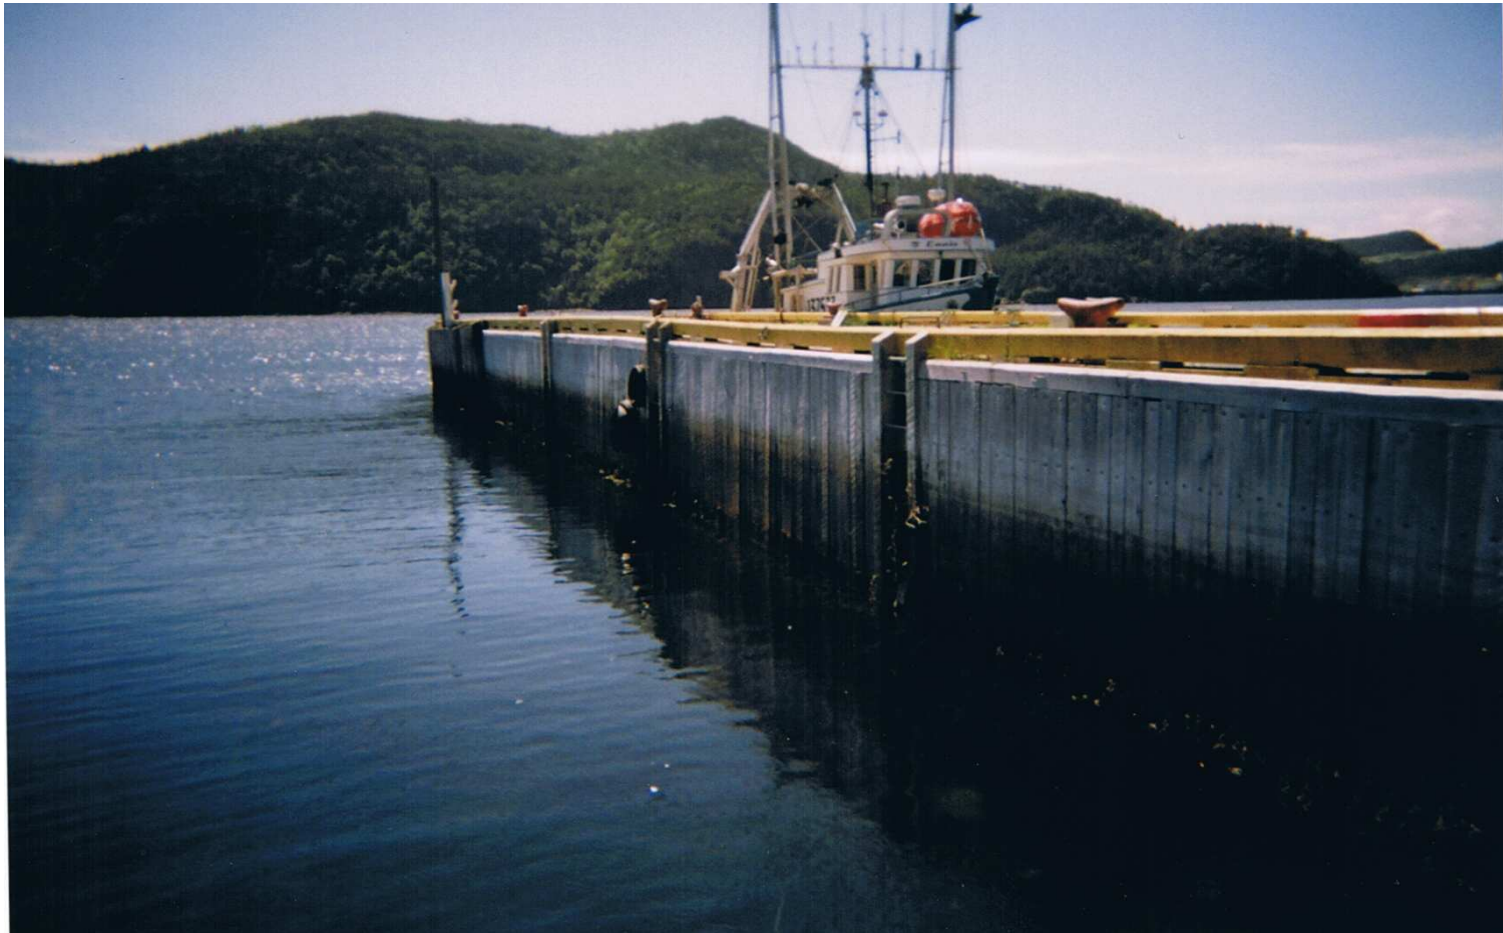
Solutions - Closed Face Fendering

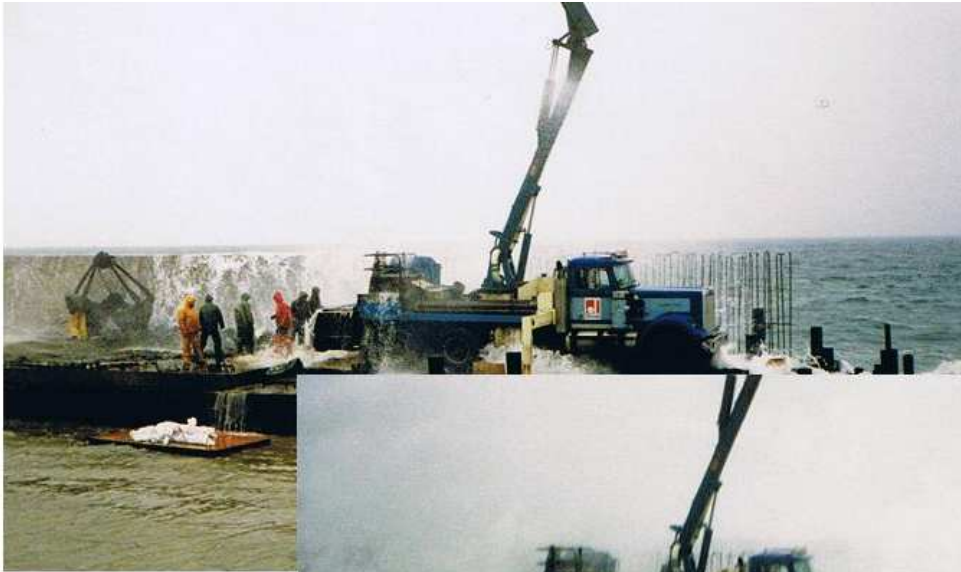
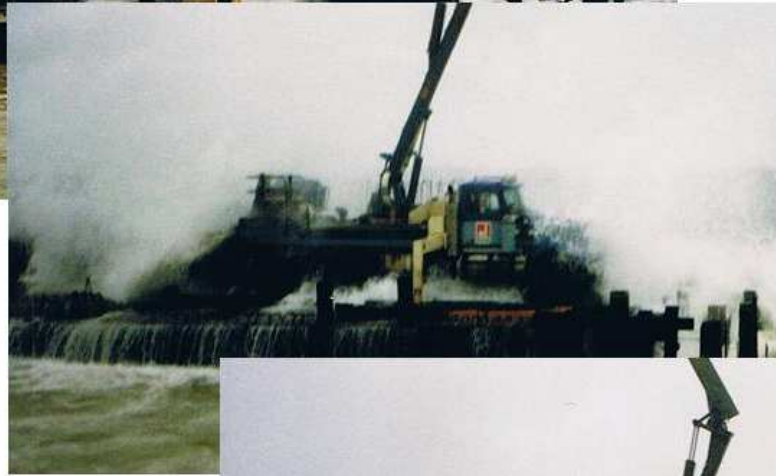
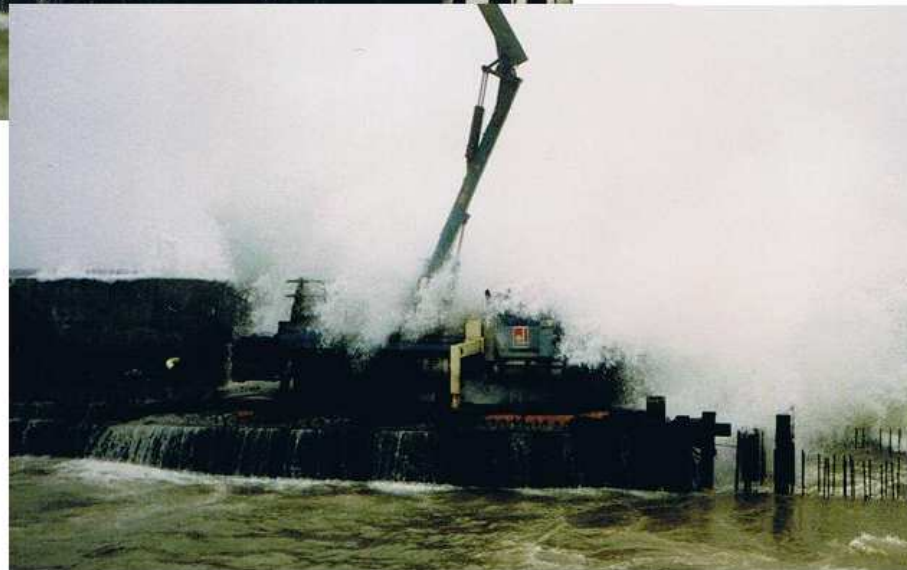
Something Cool: Pumping Concrete, St. Shott's, NL, 1991

(Note the crew working in top left picture)
