## **Appendix C**

### **MEDOF PANEL PERFORMANCE ASSESSMENT BY NRC-CHC**

R. Frederking and D. Sudom

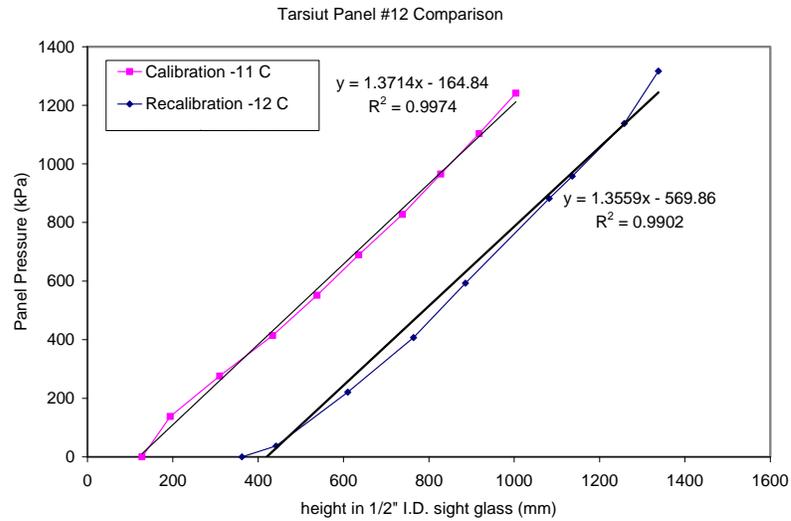
**Figure 3 Panel #12 and #14 Calibration and recalibration comparison at -10 C**

To make the comparison between the calibration and recalibration test results clearer, plots for panel #12 and #14 at a nominal temperature of -10C are presented in Figure 3.

These calibration data are summarized in Table 1. It can be seen that panel #12 experienced no change in calibration. At -10 C panel #14 showed about a 30% reduction (softening) of the calibration factor. The recalibrations of panels #20 and # 37 showed reductions of 30.5 and 33 %, respectively.

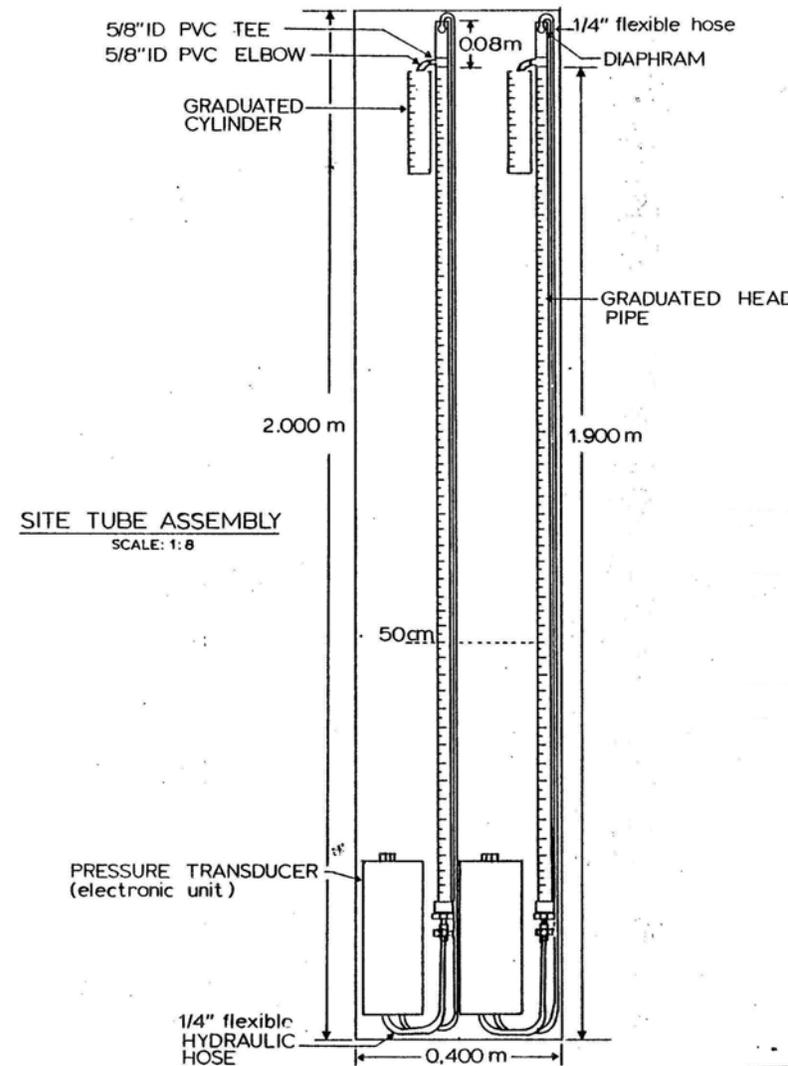
**Figure 13** Sight tube and pressure transducer set-up for MEDOF panels

To make the overload circumstances easier to follow, the arrangement of the sight tube and pressure transducer, taken from the original FMS Engineers (1983) report is illustrated in Figure 13. This shows the original installation where the sight tube was 2000 mm long. It can be seen that if a sufficiently large load is applied to the MEDOF panel it is possible for the fluid level in the sight tube to reach a point where it would overflow into the Graduated Cylinder at the top of the tube. Presumably this would allow the overflow to be measured and the maximum load determined. Once overflow had occurred, and the load was removed, it is possible for the fluid level in the sight tube to drop below the bottom inlet to the transducer and it would give a constant output, representing zero pressure.

The experience of the overload situation for panel 1010 on May 12 raised the idea of a possible way to establish an upper limit on the softening of the MEDOF panels. We have the original calibration (kPa/mm) and the maximum load on each panel during the 1985-86 season. Converting the maximum load to an equivalent maximum pressure, the increase in level in the sight tube was calculated. This increase in level (mm) was compared with the length of the sight tube to see if an overload (off-scale) condition was likely. I spoke to Alan Strandberg and he confirmed that some, but not all sight tubes were replaced with longer ones, 2400 mm in place of the original 2000 mm. He has no records of which ones were replaced.
