VIDEO ANALYSIS AND ANNOTATION OF ICE LOAD RECORDS

Brian Wright
B. Wright & Associates Ltd.
212 Carey Avenue
Canmore, Alberta
T1W 2R6

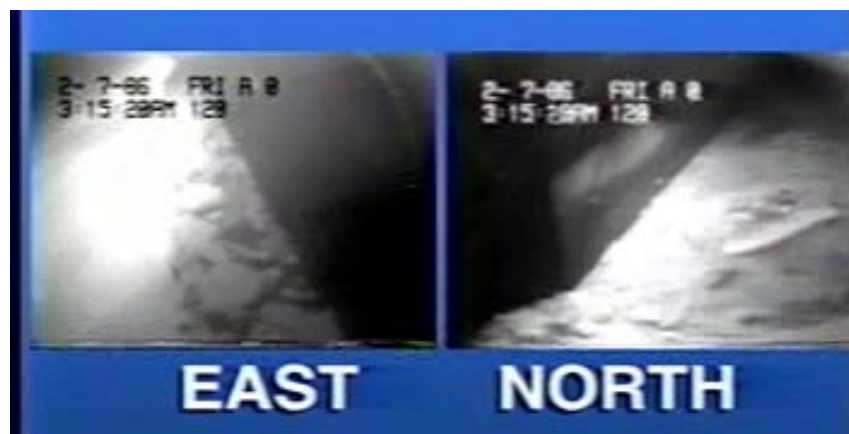
Figure 4 A similar view of the north and east faces of the caisson during darkness hours. In this case, the ice was failing against the east face in mixed modes, with broken ice debris sliding westwards along the caisson's north face.

- a large number of the time lapse video records show ice sliding along the (largely) unloaded faces of the caisson (see Figures 3 and 4)
- this is a natural part of the ice clearance process and should not be misinterpreted as ice failure against an unloaded caisson face
- when the ice attack angle is more than 50 degrees, it has been empirically estimated that the ice will begin to easily slide at low ice load levels (Neth & Spencer, 1990)
